Groundwater Report Fall 2019

# San Joaquin County Flood Control and Water Conservation District

# Flood Control and Water Conservation District

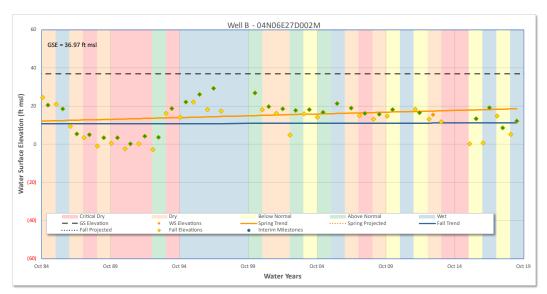
Figure 4-2 Fall Hydrograph Well A - East of Thornton Rd & South of Benson Ferry Rd.

Figure 4-3 Fall Hydrograph Well B - East of Lower Sac Rd. & South of Acampo Rd.

Figure 4-4 Fall Hydrograph Well C - North of Liberty Rd. & West of North Cherokee Ln.

Figure 4-5 Fall Hydrograph Well D - West of Elliotto Rd. & North of Jahant Rd.

Figure 4-6 Fall Hydrograph Well E - East of Davis R. & South of Armstrong Rd.

Figure 4-7 Fall Hydrograph Well F - West of Route 88 & North of Eight Mile Rd.

Hydrographs of select wells within the County are provided on Figures 4-1 through 4-27 to illustrate the changes in groundwater levels with time. Trend lines are plotted on each figure using data from 1980 to present (or shorter period if measurements are not available) to illustrate current groundwater levels, whether they are increasing or decreasing. Wells N and Q are provided but monitoring at these wells has been prevented due to access issues, but is attempting to be resolved.
